Uncle Sam Side Slope Lateral Movement - Update

Presenter: **Mosaic Fertilizer**

Date: February 11, 2019

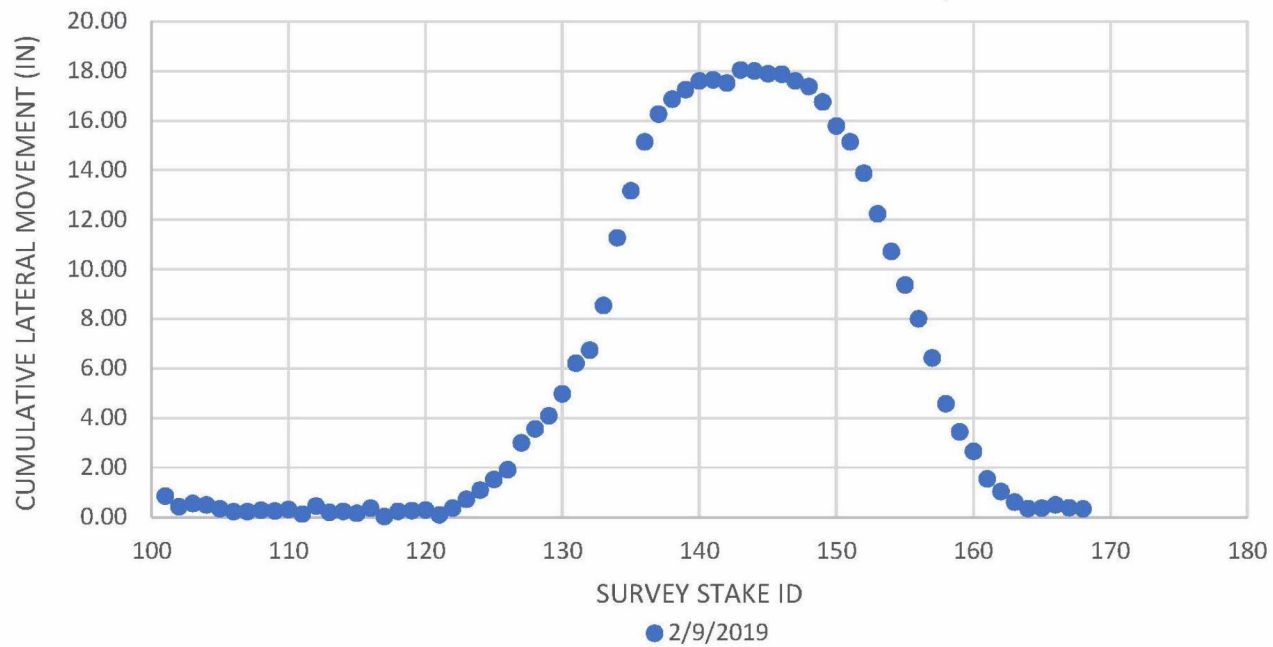
CUMULATIVE LATERAL MOVEMENT ALONG
THE NORTH EARTHEN PERIMETER DIKE
AS OF FEBRUARY 9, 2019
SINCE SURVEY STAKE INSTALLATION ON JANUARY 11, 2019

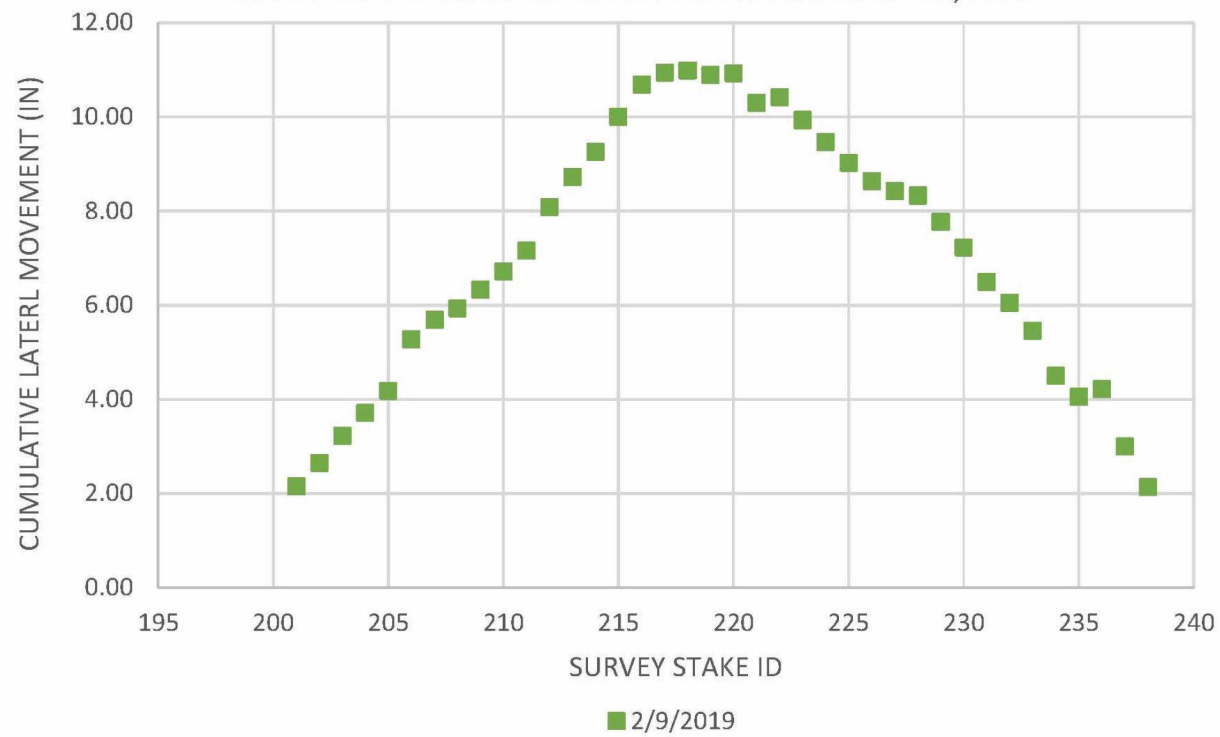
CUMULATIVE LATERAL MOVEMENT ALONG
THE CREST OF NORTH GYPSUM DIKE
AS OF FEBRUARY 9, 2019
SINCE SURVEY STAKE INSTALLATION ON JANUARY 11, 2019

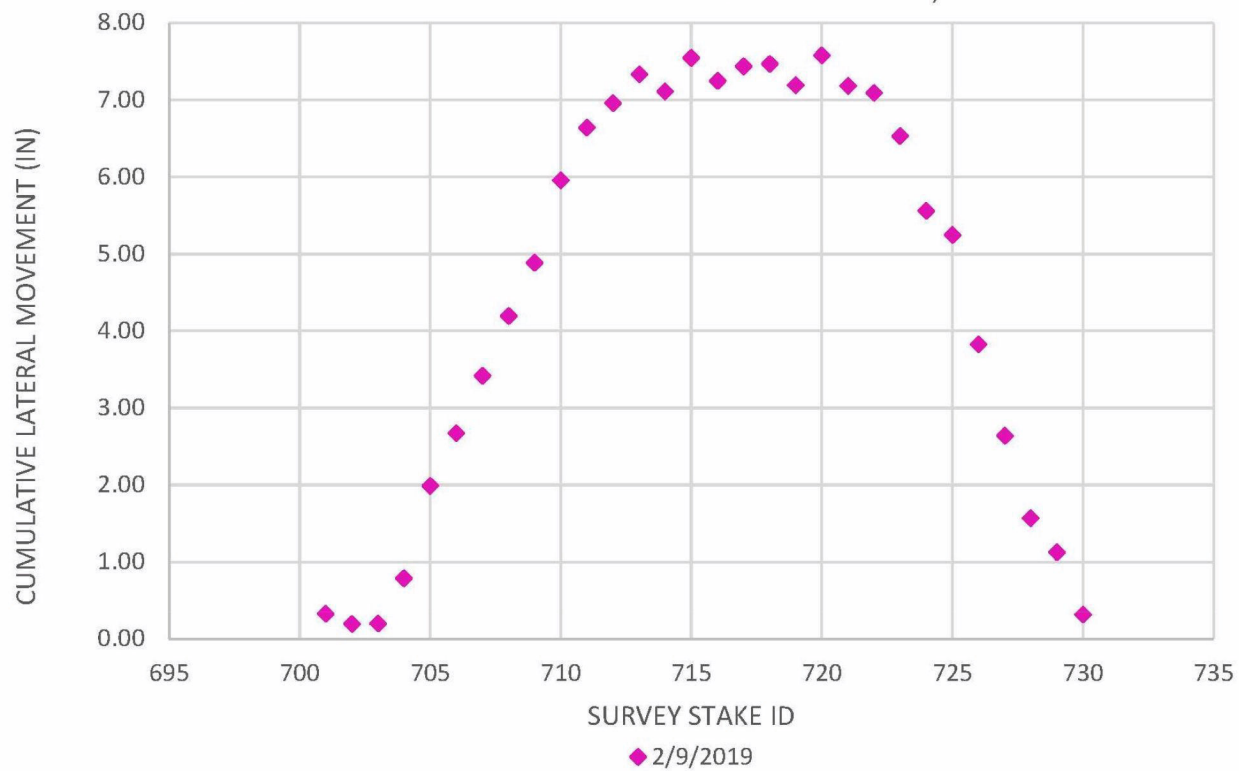
CUMULATIVE LATERAL MOVEMENT ALONG
THE MID-NORTH SLOPE
AS FEBRUARY 9, 2019
SINCE SURVEY STAKE INSTALLATION ON JANUARY 28, 2019

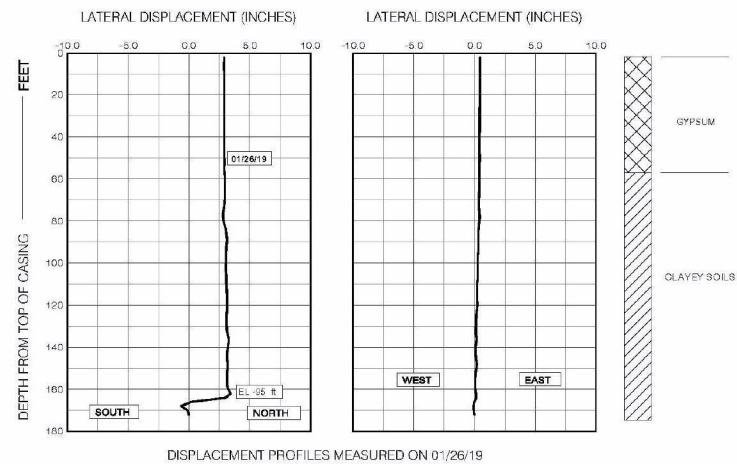
**SUMMARY OF LATERAL DISPLACEMENTS
AT NORTH BENCH OF STACK NO. 4
(INCLINOMETER SI-N2)**

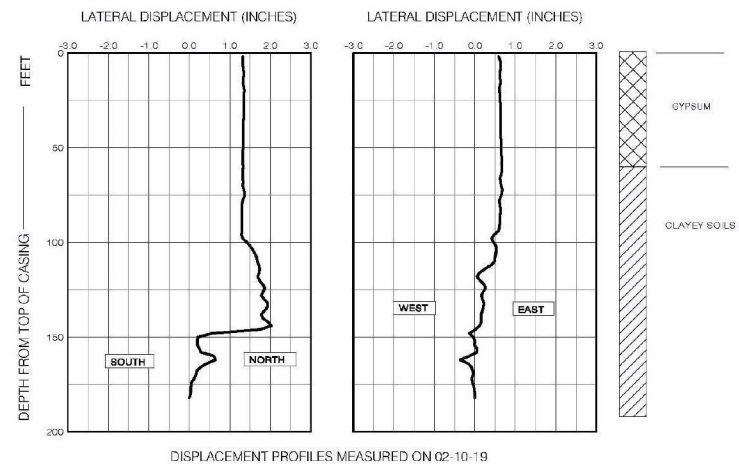
**SUMMARY OF LATERAL DISPLACEMENTS
AT WEST SIDE OF MID-NORTH SLOPE
OF STACK NO. 4
(INCLINOMETER SI-6B)**

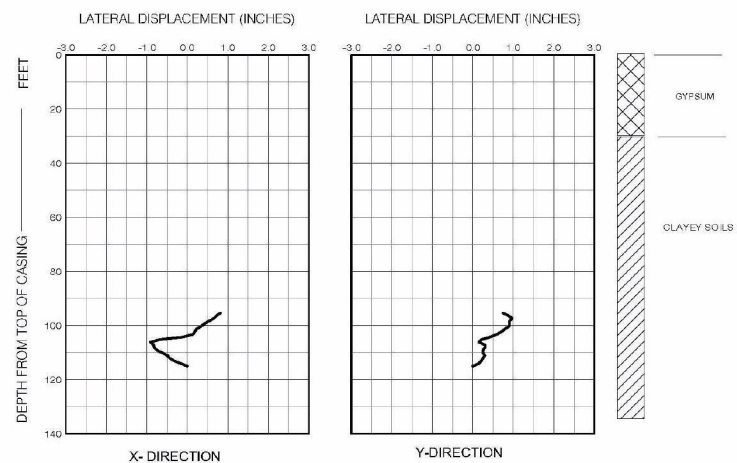
DISPLACEMENT PROFILES MEASURED ON 02-10-19

**SUMMARY OF LATERAL DISPLACEMENTS
AT EAST SIDE OF NORTH LOWER
SLOPE OF STACK NO. 4
(SHAPEACCELARRAY SAA-NE)**

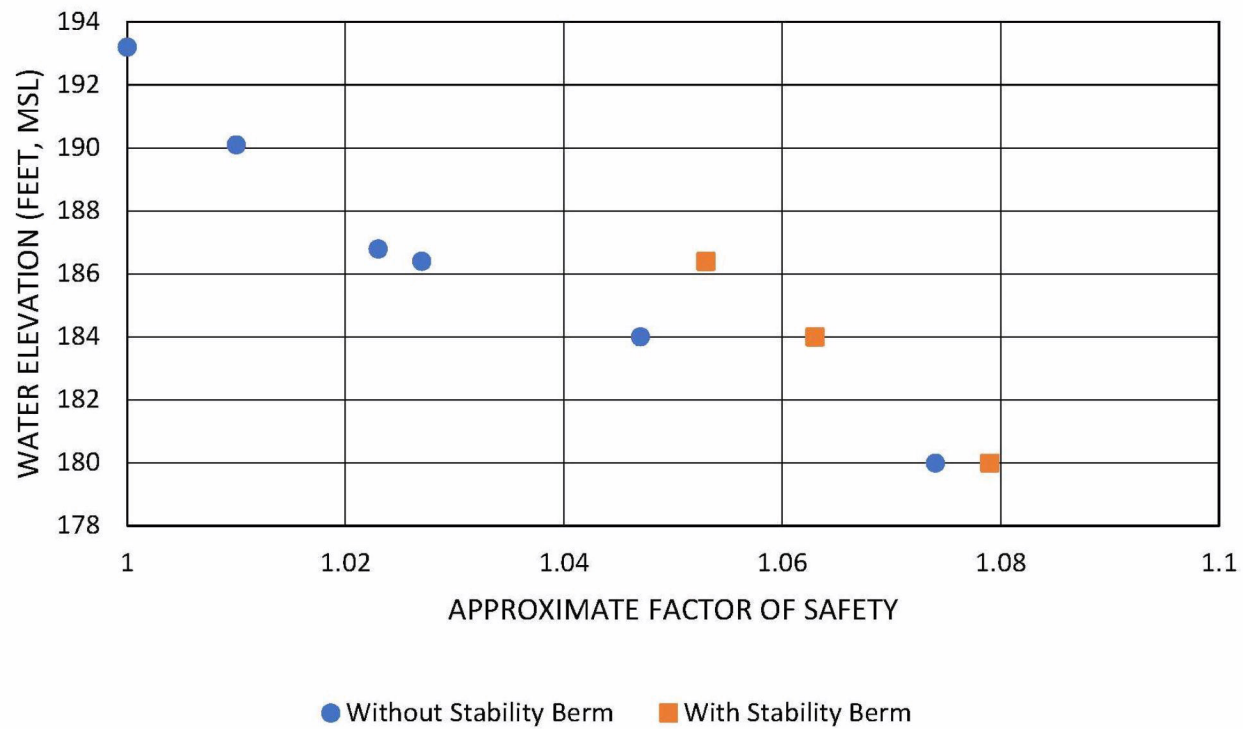
WATER LEVEL ELEVATION ON STACK No. 4 COMPARTMENT
VERSUS APPROXIMATE FACTOR OF SAFETY

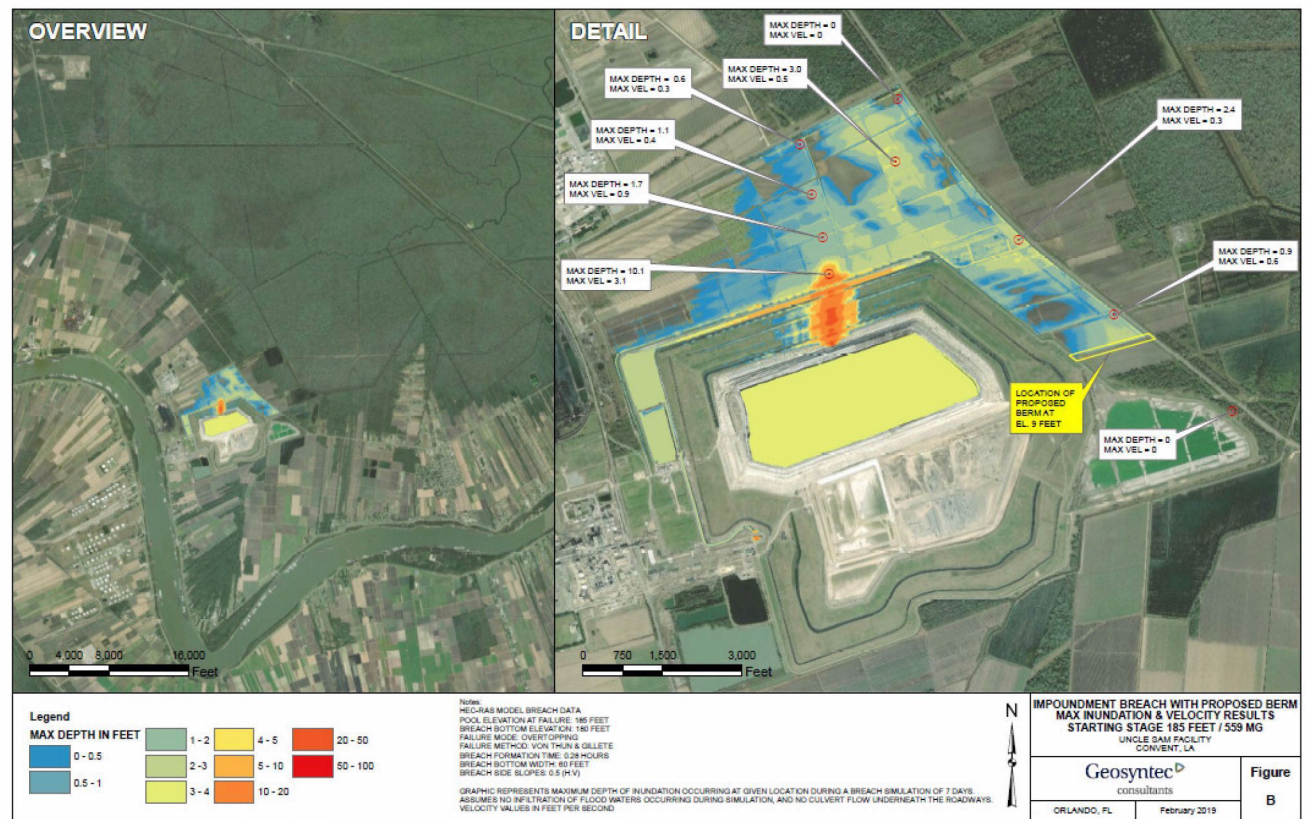
Inundation Scenario 185' to 180' Pond Elevation Change

- Release volume is worse case scenario with pond at elevation 185' at beginning of failure and 180' at the end
- The initial elevation reflects level after 110 acre reservoir receives 200M gallons
- Release volume is 159M gallons
- Failure mode is unlikely to occur as rapidly as model estimates
- Simulation reflects completion of El. 9' dike between perimeter dike and HWY 3125
